# Going underground

## A Cumbrian perspective

*As the demand for new housing rises still further, the countryside continues to be eaten away by sprawling suburban developments. One type of construction with the potential to start redressing the balance is the underground home. Phil Reddy, who now lives in his recently constructed subterranean house in Cumbria, writes of the challenges encountered and solutions achieved during the project, and of the benefits of underground living*

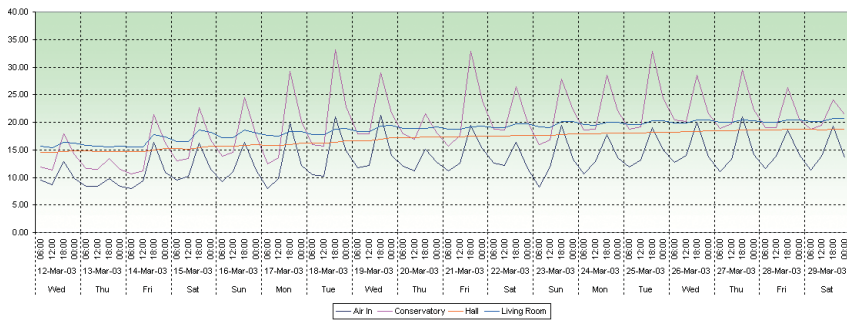
Figure 3 The average six-hourly temperature from 12–29 March 2003

The graph above (Figure 3) shows the average six-hourly temperature for the period from 12 to 29 March 2003, with pulses of energy represented by the top line, which records the temperature at mid-height in the conservatory. The lower line shows the temperature of incoming air, as measured from within the house, on the outside of the metal pipe bringing this air into the ventilation system. The upper of the two middle lines shows the temperature at floor level in the living area, and the lower line shows that at floor level in the hall. All readings are in degrees Celsius.

Although the house had never been cold, it was not always comfortable, so additional heat from a small fan heater was used during the winter months. A dehumidifier was also used. The graph shows very clearly how the energy input during the period covered raised the temperature of the living area by 5°C and that of the hall by over 4°C. The rise in temperature within the house was helped by deliberate use of opened doors to take full advantage of the heat within the conservatory and by limiting the use of windows in the conservatory to lower temperatures there.

Table 1 summarises the results shown in the two graphs and makes clear the difference between the two periods in terms of the impact on temperatures within the house.

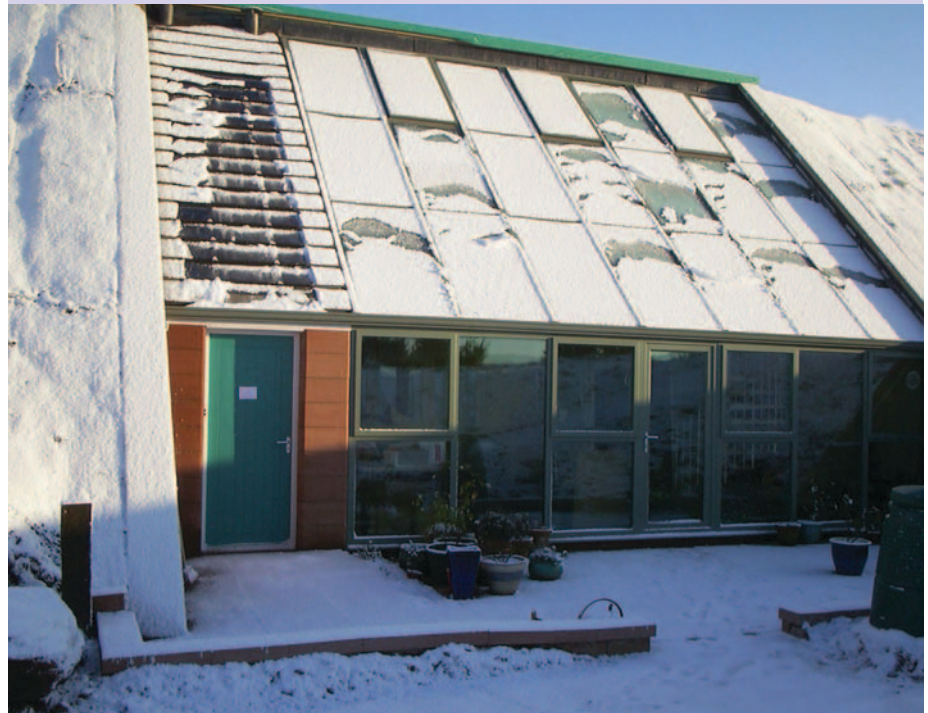
**Figure 7** Architect's elevation plan and the completed house, showing the double storey conservatory that fronts the property, maximising the amount of natural light inside

selected was to use high-density hollow blocks threaded over reinforcing bars and filled with concrete for the main structural walls. The front wall is different, being made of solid blocks with an insulation filled cavity. The intermediate floor and roof are of poured and reinforced concrete, onto integral metal formwork. Hidden

buttresses provide structural support for the conservatory walls and act to prevent any forward movement of the building. The solution has resulted in a very strong building that was relatively straightforward to produce.

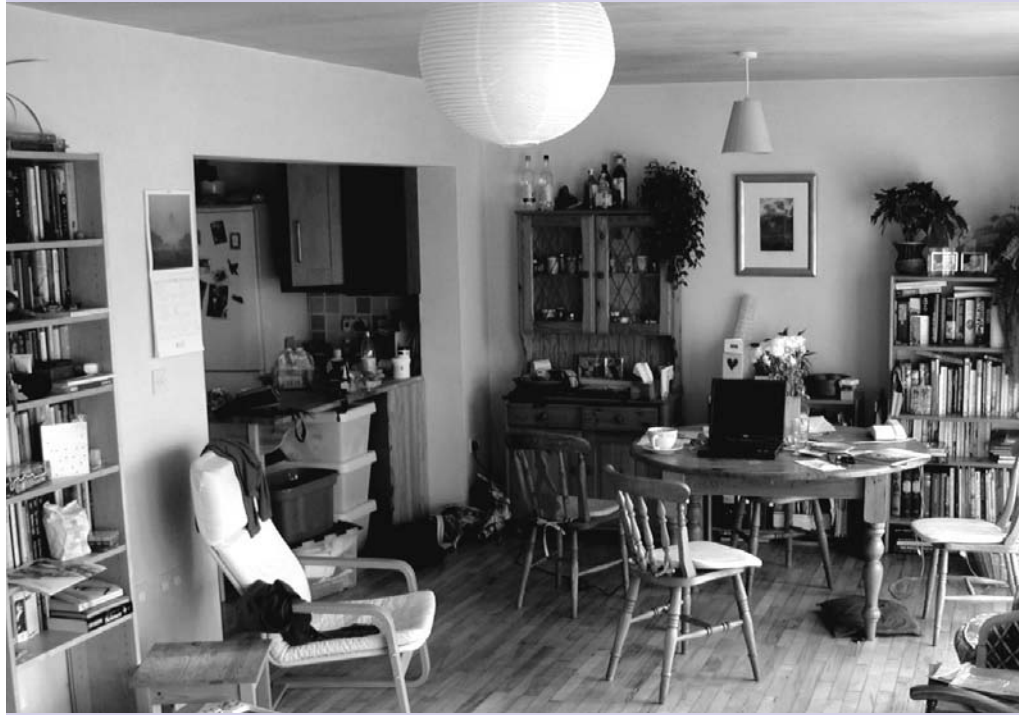
Figure 5 Light floods through the glass into the front of the house

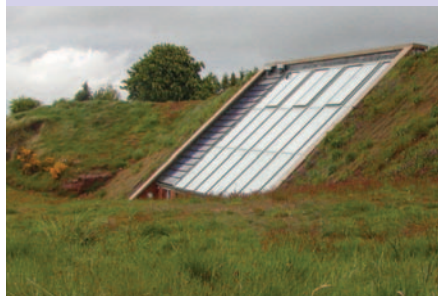
Figure 6 Set into the ridge, the house is surrounded by 350 million-year-old sandstone

Finding a possible site proved straightforward. An example of a drumlin – a glacially produced ridge – running broadly east to west provided an ideal location, particularly since it had a number of small, disused quarries cut into the southern slope. The ridge itself is a layered mixture of sandstone, shale and limestone, the sandstone having been laid down around 350 million years ago as part of an estuarial system. Agreement was quickly reached to purchase the area around one such quarry, subject to planning permission being granted.
